## CASE STUDY

# Carbon Contaminated Dark Gas Oil

## Brand new yacht dark gas oil found to be carbon contaminated.

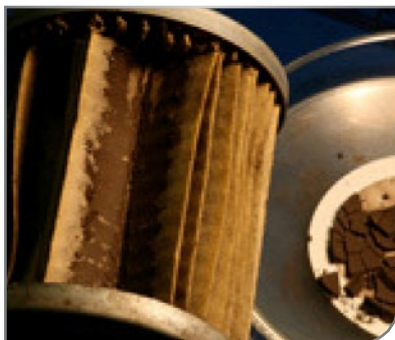
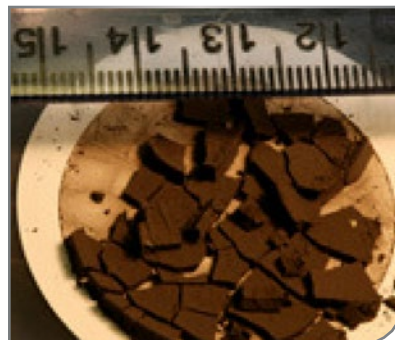
Visual inspection of the various fuel samples showed some dark discoloration untypical for marine gas oil. Visual inspection of the fuel filters showed a thick black fluid deposit. Spectrographic analysis of the fuel samples indicated no presence of lubricant additives. Lubricating oil samples were tested for Flash Point to show any possibility of fuel/lubricant crossover – results were satisfactory. Different fuel samples were tested for microbacteria contamination – results were negative. Fuel samples were tested for Micro Carbon Residue (MCR) all of which were typical for marine gas oil. The black fluid deposit from the fuel filter was tested for MCR and gave a result of over five percent. Further analysis of the black fluid deposit in the filter using Scanning Electron Microscope (SEM) produced a deposit of over 300mg consisting of very fine particles below 10 microns.

Marine gas oil should be clear, bright and usually colour tinged. It should also be free from visible debris. There is virtually no Carbon Residue in marine gas oil. Finding over five percent MCR in the residue from one of the fuel filters, together with the fine carbon flushed from the filter tested in the SEM confirmed an external contamination of the fuel by fine carbon.

Initial results were discussed with the customer and further analysis agreed. The customer proceeded to pump ashore all fuel and clean the entire system. Further samples were taken which showed black thick fuel towards the bottom of each storage tank. On shaking these fuel samples, the fine black substance could be seen to settle out over a short period of time.
