CASE STUDY
ITT drop indication

Decrease in ITT prior to planned maintenance work helps find unexpected part failure and optimises downtime.

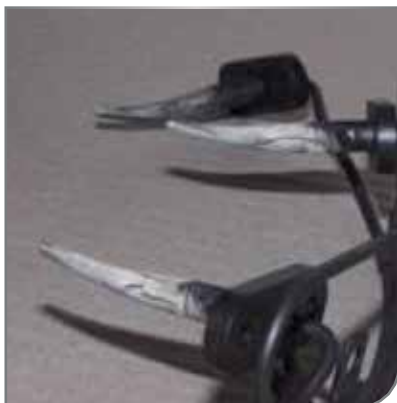
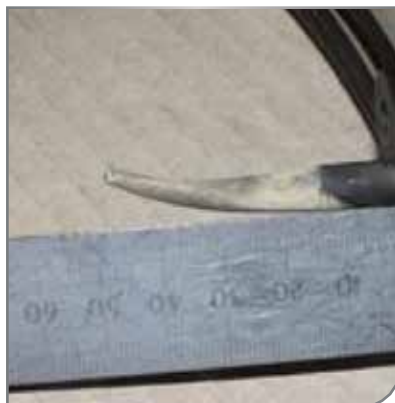
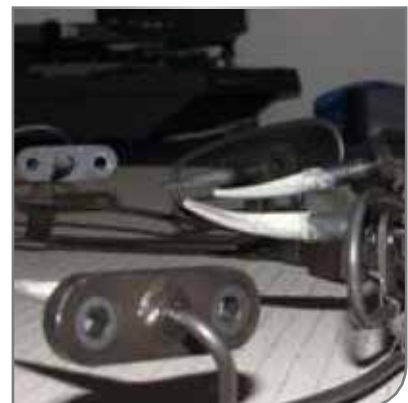
The analysis of the trend from the engine showed a gradual decrease in ITT throughout the period covered by the download

Investigation of the ITT system revealed curling of most of the ITT probe tips as shown in the photographs. The entire harness was replaced.
