## CASE STUDY

# Helicopter Chip Warning Light Indication

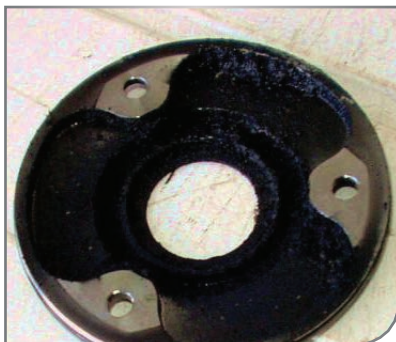
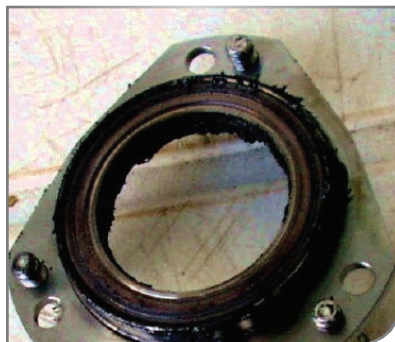
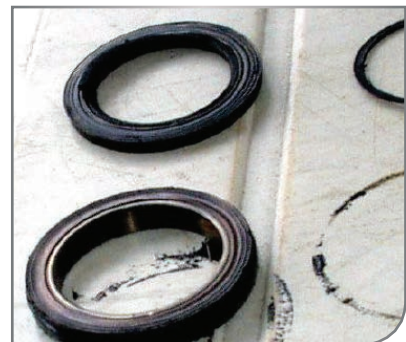
Major:	Carbon, Miscellaneous-Mainly fine particles
Minor:	Nil
Significant Trace:	Flakes and Slivers of a 0.5% Nickel, 12% Chromium steel such as Z12CN13 measuring up to 0.2mm across and 0.4 X0.1mm respectively
Significant Traces:	Aluminium alloys – corroded fragments measuring up to 0.3mm across
Recommendation:	Consult a field engineer with regards to the significant trace presence of Z12CN13 steel flakes

The initial analysis results were passed to Turbomeca who advised the Maintenance Company to examine the magnetic seals on the Engine Output shaft, Centrifugal Breather shaft (Oil/Air separator) and Starter/Generator shaft. Following the second chip detector activation and subsequent investigation it was found that on the Starter/Generator shaft the carbon face on the seal had worn away/broken off, so it was a direct metal to metal contact.
